# International Conference on Space Optics—ICSO 2014

## *Failure analysis on optical fiber on swarm flight payload*

## FAILURE ANALYSIS ON OPTICAL FIBER ON SWARM FLIGHT PAYLOAD

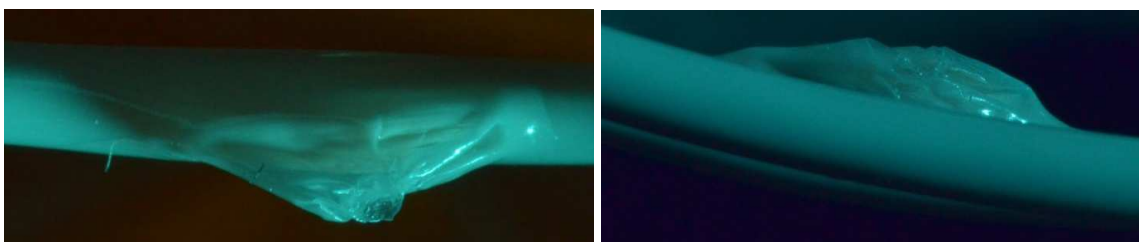
On the following pictures and from two different views, the jacket absorbs the 450 nm excitation light, and then behaves as a source at higher wavelengths “Fig2”. It is no longer transparent. This confirms that a thin film of fluoropolymer is still covering the aramid fibers.

**Fig 2:** 450nm excitation wavelength.

- A thin film of fluoropolymer is still covering the aramid fibers.
- The aramid fibers have been displaced 1.5 mm over the jacket. They seem to remain braided however, they are not broken.
- We do not see anything from deeper internal materials.

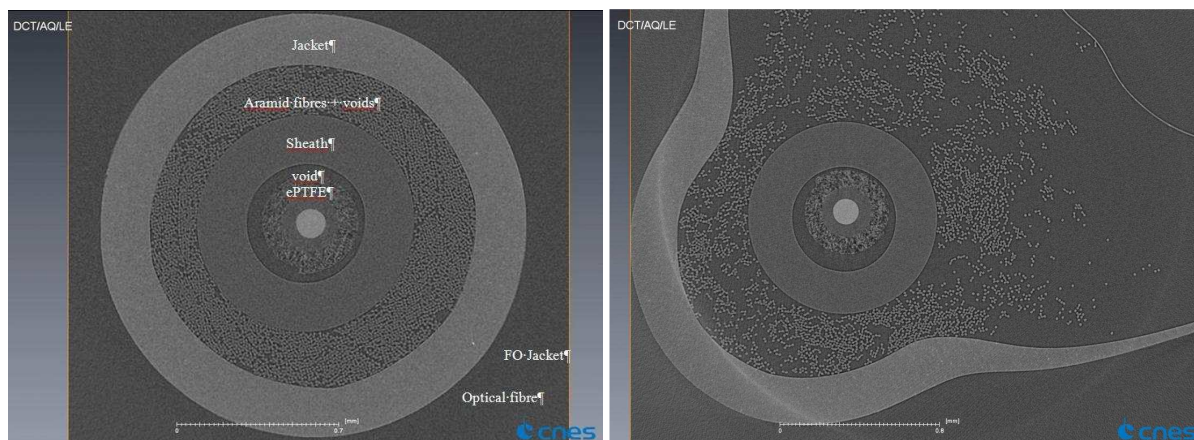
IABG mentioned a possible incident due to the use of a hot air gun too close to the optical fiber. We performed different tests and reproduced the damage. The following tomography “Fig 6” and cross-sections “Fig 7” images show that at these temperatures (about 500°C / 20 seconds) the shape of the sheath is preserved. It means that the optical fiber is still free to move in the sheath and thanks to the Aramid fibers; the excess of heat has been dissipated along the cable. The ePTFE also plays a role in this dissipation.

**Fig 6:** X-ray pictures extracted from tomography videos showing the different protection layers in order to assess the depth of damage

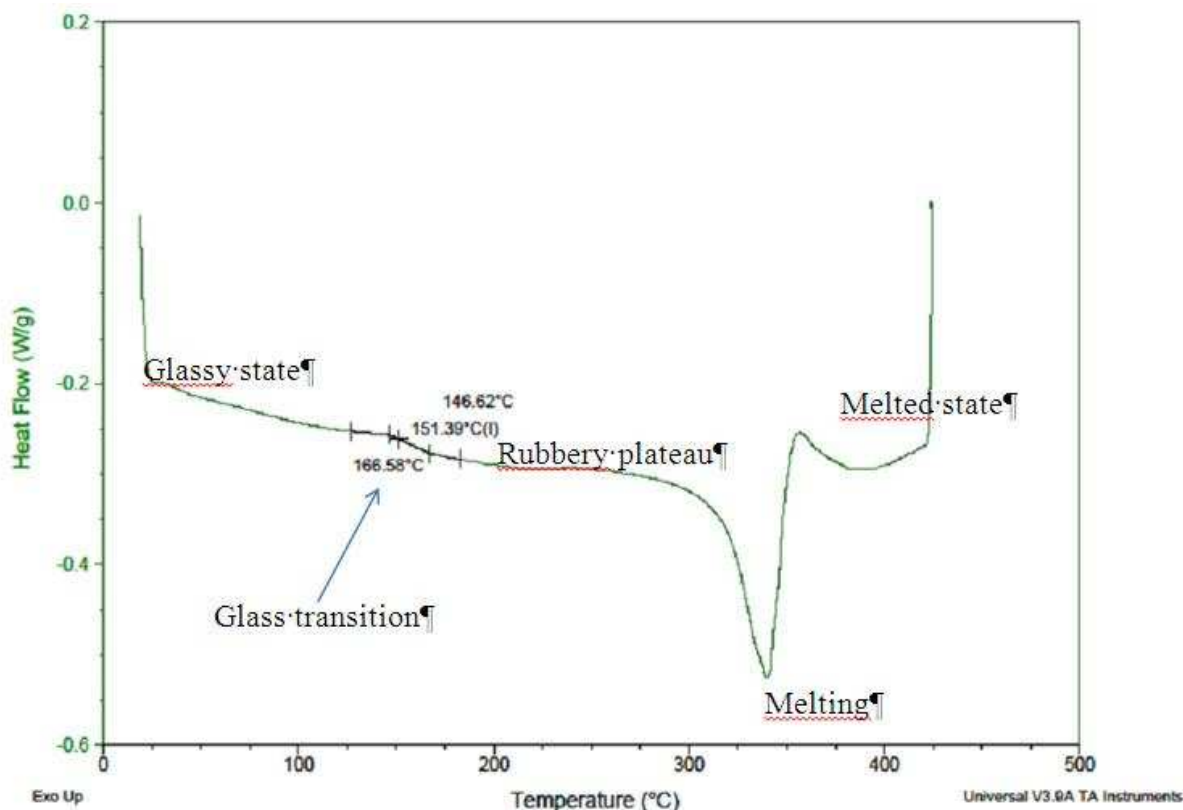
In addition, differential Scanning Calorimetry measurement on the sheath “Fig 8” showed that the glass transition temperature at a rather high temperature is the same for the heated and the unheated overall optical cable.

Fig 8: Differential Scanning Calorimetry measurement on the sheath
